LM	1	Lindow Moss Restoration Scheme	Article No./Reference
Designed by JEJM	Checked by BRCM	Approved by - date BRCM-21/11/14	Date 21/11/14
		File name RS_05.DWG	Scale 1:3000@A3
TERRAQUEOUS LTD. ENVIRONMENTAL CONSULTANCY		FIGURE 5: INDICATIVE RESTORED DRAINAGE PLAN	
Reproduced from the 2014 Drainage Survey 1:2,500 map with the permission of The Controller of Her Majesty's Stationery Office, ©Crown Copyright Terraqueous Ltd., Meone, Glastonbury, Somerset BA6 9SP. Licence No. AL 52095A0001

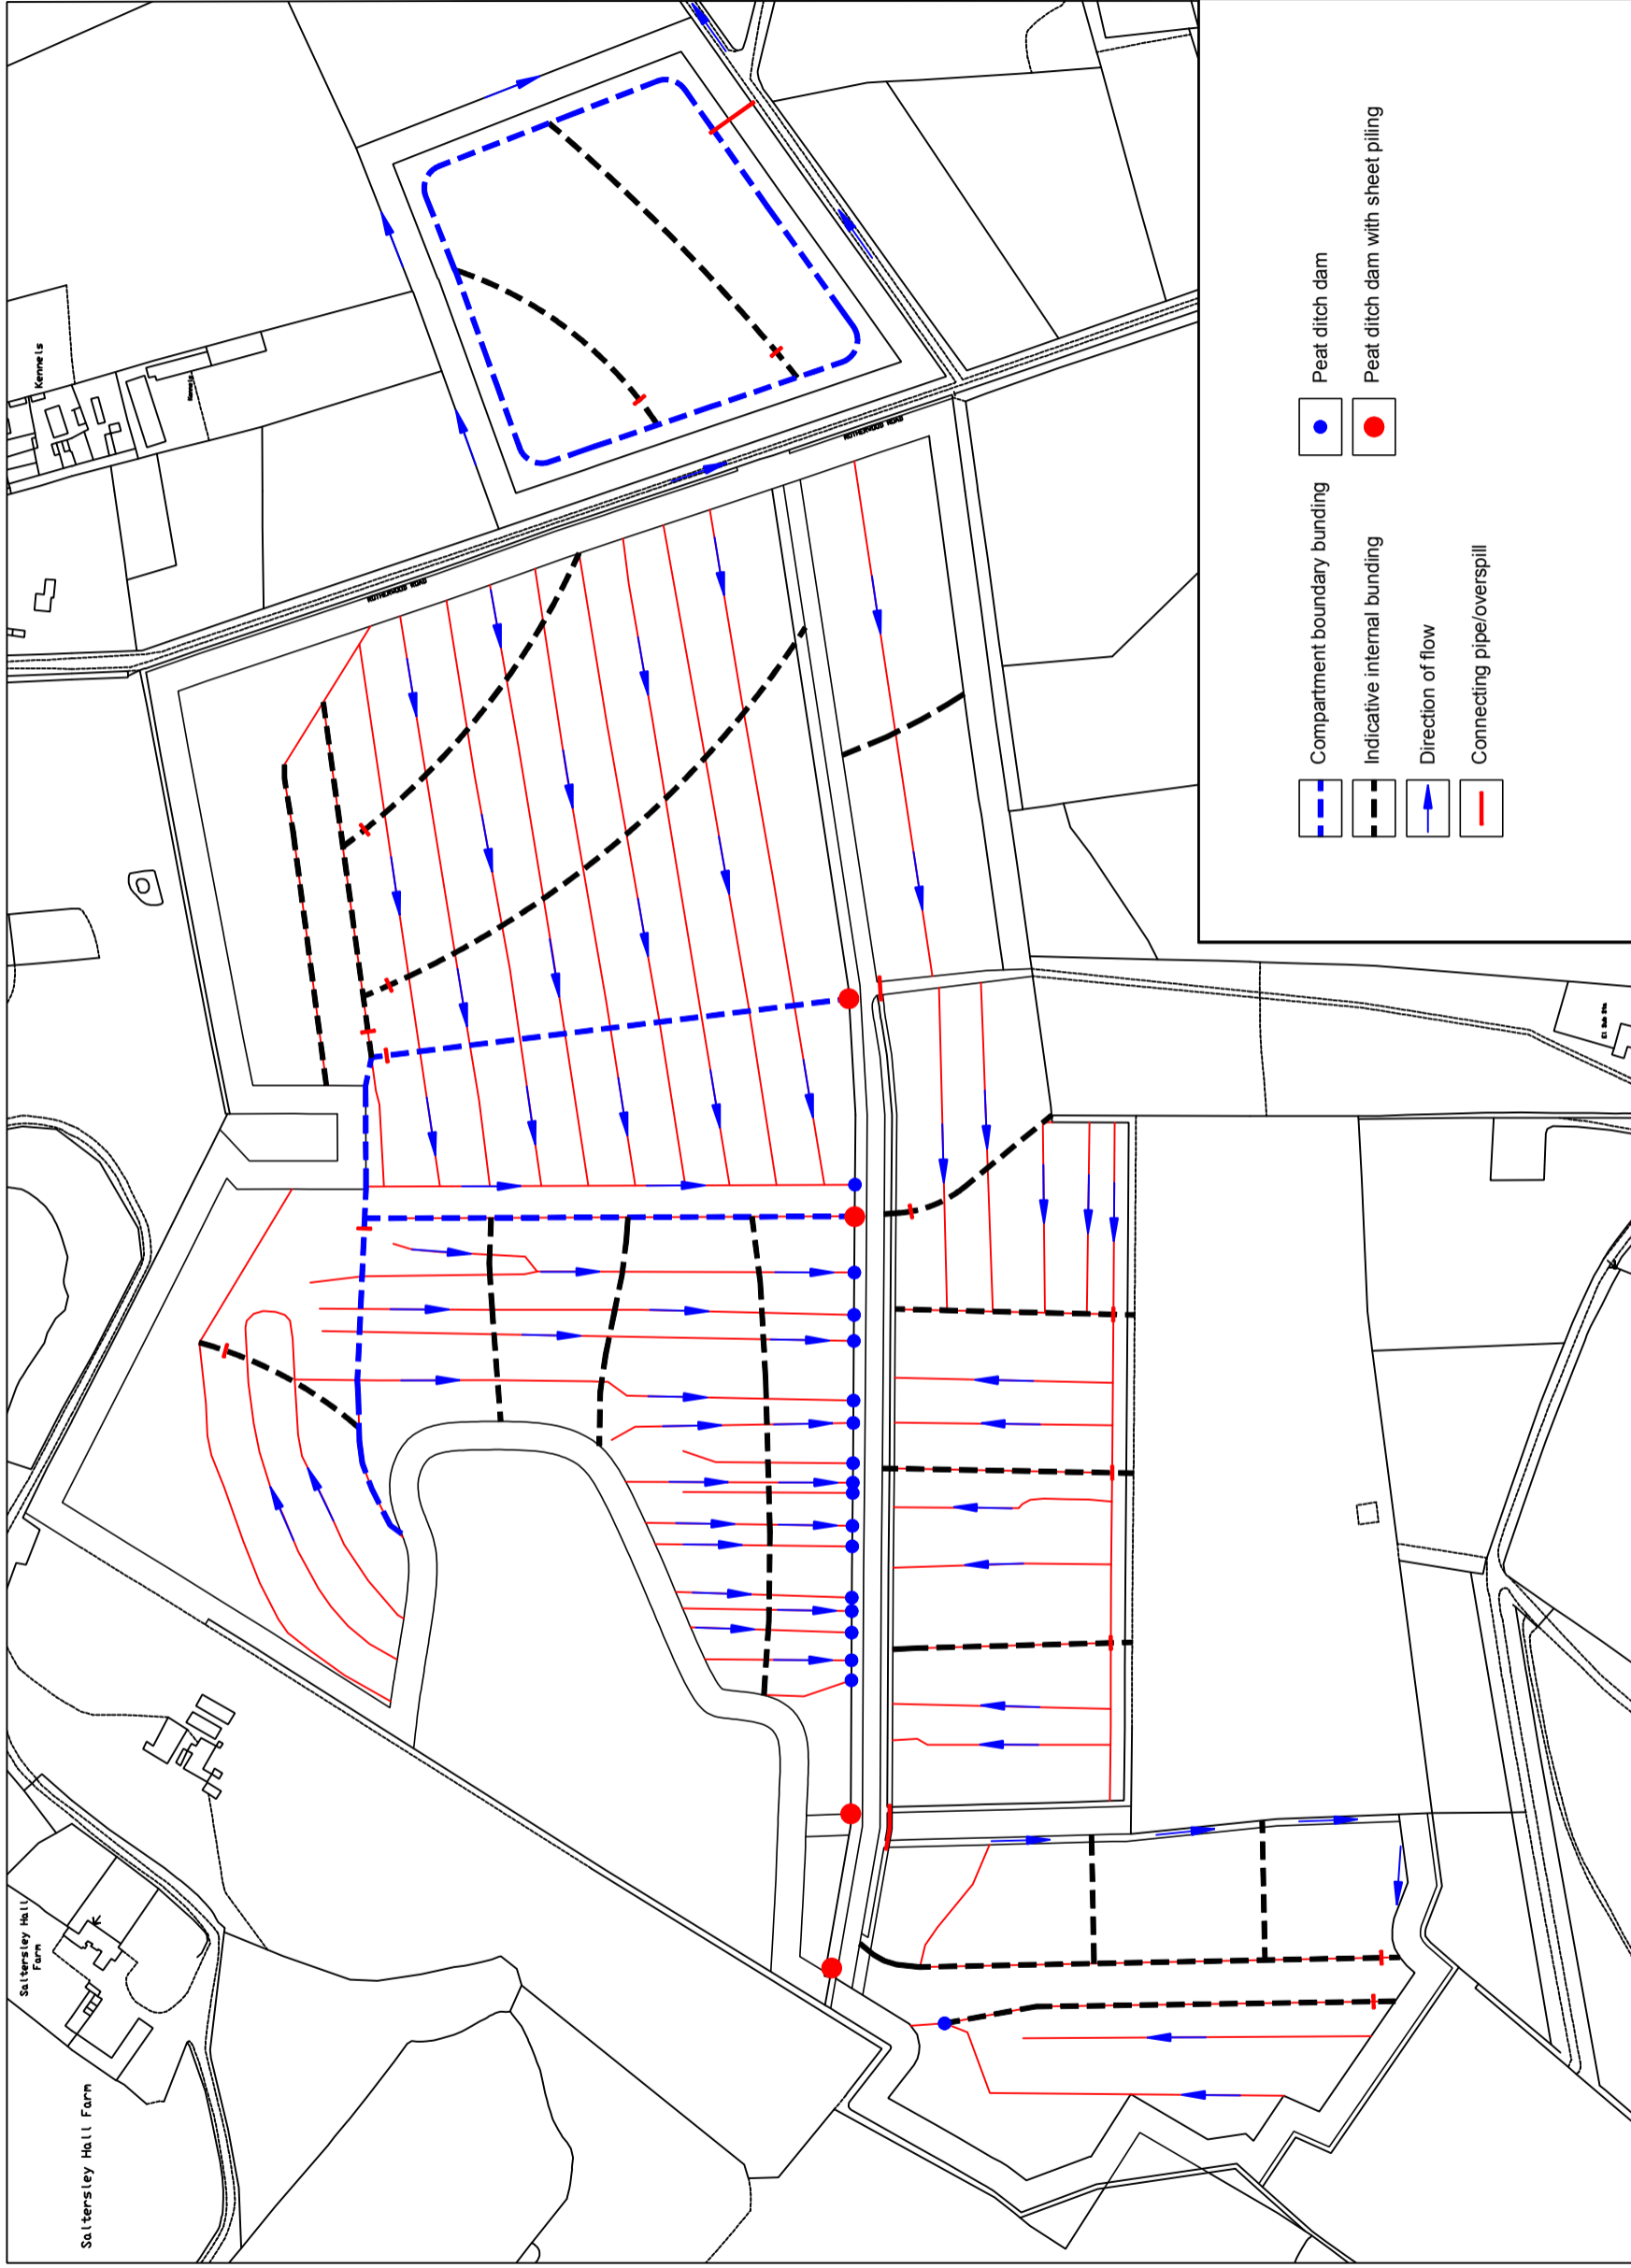
Compartment boundary bunding
-

Indicative internal bunding
-

Direction of flow
-

Connecting pipe/overspill
-

Peat ditch dam
-

Peat ditch dam with sheet piling
